# VR65 ENGINE: AFFIX NEW VACUUM HOSE ROUTING LABEL

1993 Volkswagen Corrado

EMISSION RECALL BULLETIN

VACUUM HOSE ROUTING LABEL REPLACEMENT - RECALL CODE SQ

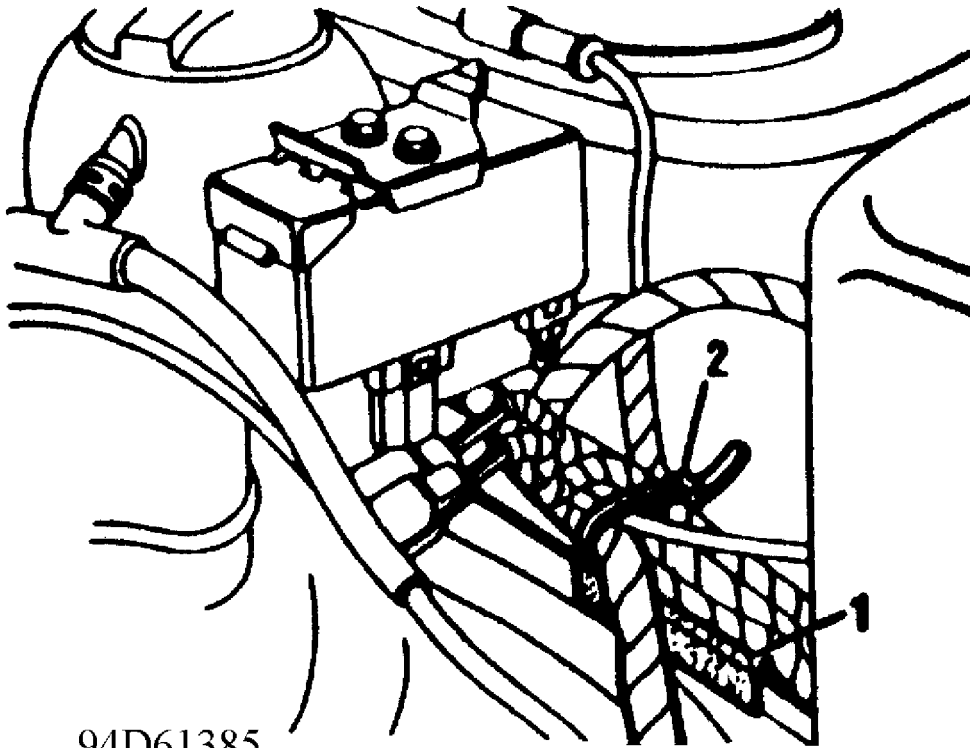
Fig. 10: Securing Engine Compartment Harness

Volkswagen has found that an electrical wiring harness located in the engine compartment may have been routed too close to a sheet metal edge during assembly. If this happened in your car, the wiring could be damaged due to chafing during normal operation of the vehicle.

- Open re-usable tie wrap (see Fig. 10, marked "2")
- Install beading, part number 701 947 149A over sheet metal edge (see Fig. 10, marked "1")
- Route harness over beading, re-secure with reusable tie wrap.
- Re-install battery.
- Remove power saver.

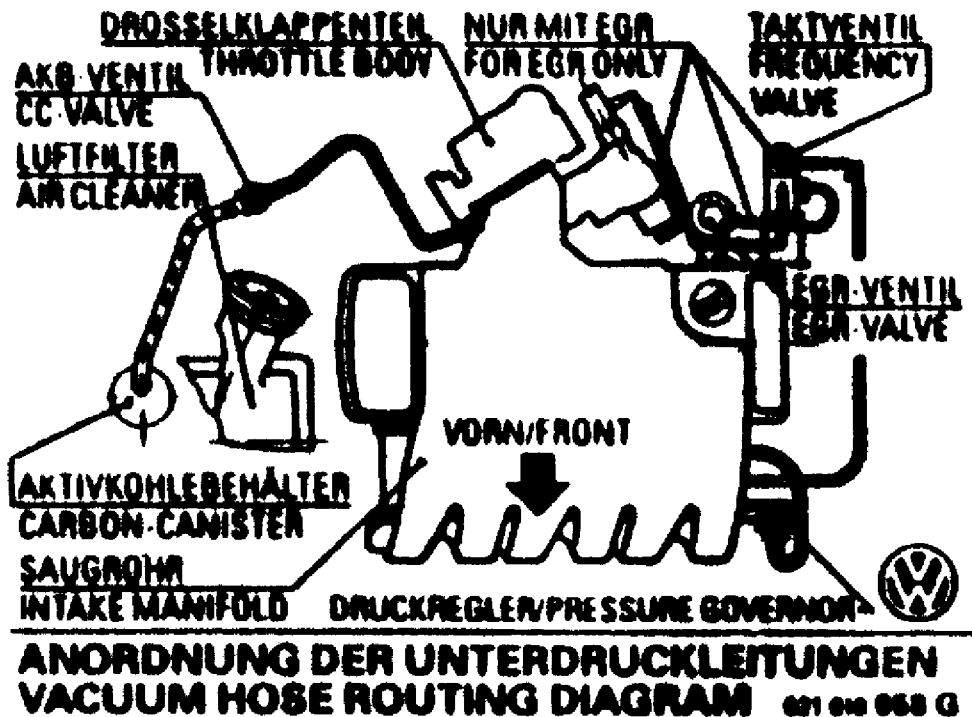
Fig. 12: Vacuum Hose Routing Label

Volkswagen has found that affected Corrado VR6 vehicles were inadvertently equipped during assembly with a label containing emission specifications intended and applicable to Passat model VR6 vehicles. The diagram of the vacuum hose routing is incorrect as applied to the Corrado.

- Clean existing label under engine hood.
- Remove protective backing from new label, part number 021 010 058G. See Fig. 12.
- Affix new label over existing label.
