1.9L - TOOTHED BELT RUNS TOWARDS OUTSIDE/JUMPS OFF

TOOTHED BELT RUNS TOWARDS OUTSIDE, WEARS OUT, JUMPS OFF, CRACKS

Model(s): 1994-97 Volkswagen Golf, Jetta, Passat with 1.9L
(Engine code AAZ, 1Z)
Group: 15 - Engine - Cylinder Heads Valve Drive
Bulletin No.: 97-01
Date: June 4, 1997

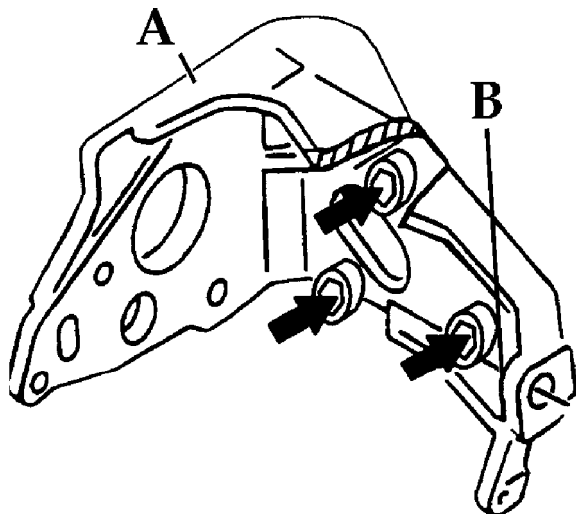
Fig. 1: Injection Pump Bracket & Mounting Bolts

Toothed belt runs toward outside and wears out, jumps off, cracks or is noisy.

If belt protrudes beyond face of crankshaft sprocket, adjust Diesel Injection pump mounting bracket as follows:

- Remove injection pump.
- Slightly loosen three fasteners securing bracket to engine. See Fig. 1, -arrows-.
- Press bracket down at point -A- and lift at point -B- while a second Technician torques fasteners -arrows- to 25 N.m (18 ft-lb.). See

- Reinstall injection pump.
