NO START/HARD START/POOR RUNNING(DISTRIB CAP ARCING) GROUP 28, NO. 91-01

NO START/HARD START/POOR RUNNING (DISTRIBUTOR CAP ARCING)

Model (s): 1987- on Volkswagen, All Models With 16V Engine
Group: 28 - Ignition System
Bulletin No.: 91-01
Date: October 31, 1991

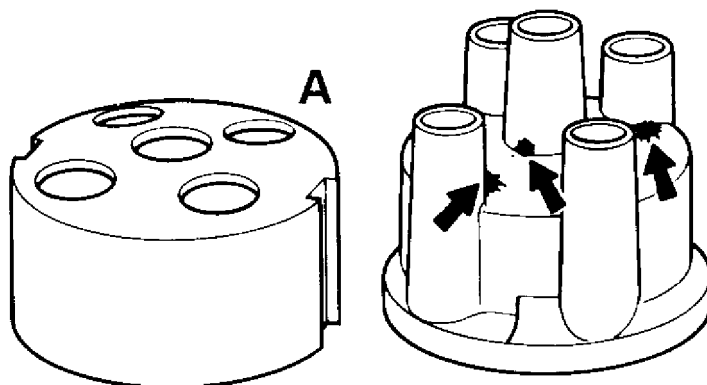
91D34598

High tension arcing on distributor caps, resulting in poor starting and poor running.

- Remove distributor cap.
- Inspect inside of cap for arcing and carbon tracking.
- Remove ignition wires from distributor cap and visually inspect wires.
 - * Ensure that terminals are strong and clean, replace any wires with burned terminals.
- Measure resistance of ignition wires and distributor rotor, replace any that do NOT meet specifications.
 - * Spark plug connector - 5,000 Ω 1,000 Ω
 - * Cap connector - 1,000 Ω 200 Ω
 - * Coil connector - 1,000 Ω 200 Ω
 - * Distributor rotor - 1,000 Ω 200 Ω
- Remove static noise suppressor, -A- (black plastic) from distributor cap. See Fig. 1.
- Inspect outer surface of distributor cap for arcing and carbon tracking. See Fig. 1 (arrows).

Fig. 1: Distributor Cap With Carbon Tracking

- Install new distributor cap with suppressor (sold as an assembly).

NOTE: Before assembling cap, you may use a dielectric spray on the outer surface of the distributor cap and on the inner surface of the suppressor shield to further reduce the possibility of arcing.
