Recall Circular

Code: **UE**

April 1999

**Subject: 1992-94 Volkswagen Corrado Vehicles
Equipped With VR6 Engines
Modify Engine Coolant System**

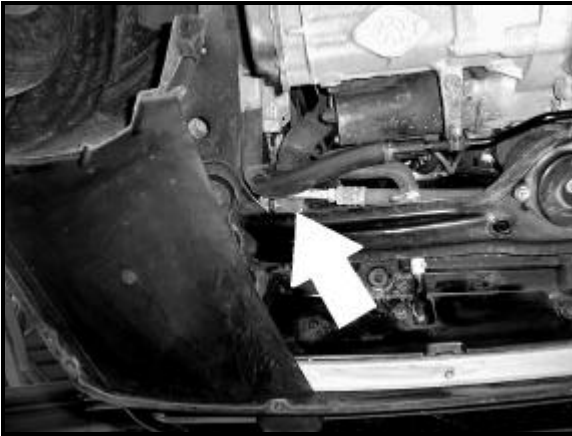
- Bring vehicle into service area: switch ignition to off position
- Record radio code and radio pre-set stations
- Open hood and disconnect the battery ground (GND) cable
- Carefully loosen coolant expansion tank cap to relieve pressure
- Raise vehicle on hoist
- ⇐ At left front of the vehicle, loosen clamp (arrow) on lower coolant hose to radiator using special VW hose clamp removal tool VAG 1921 or similar
- Cautiously disconnect hose from the radiator to drain coolant

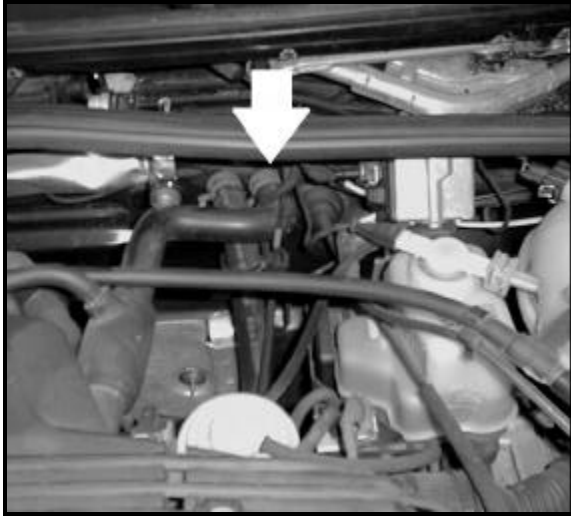
- While coolant is draining, lower vehicle to floor level being careful not to damage drain pan
- ⇐ Use special VW hose clamp removal tool VAG 1921 or equivalent to remove clamp from left (outward) heater hose (inlet hose to heat exchanger) at firewall
- Disconnect hose from heat exchanger

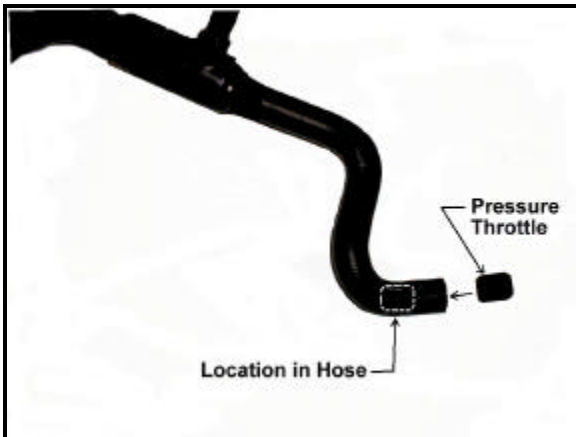
- ⇐ Insert pressure throttle (1H0 121 135) from kit (1H0 198 998) into hose approx. 25 mm (1 in.)
- Reconnect hose to heat exchanger and secure with clamp

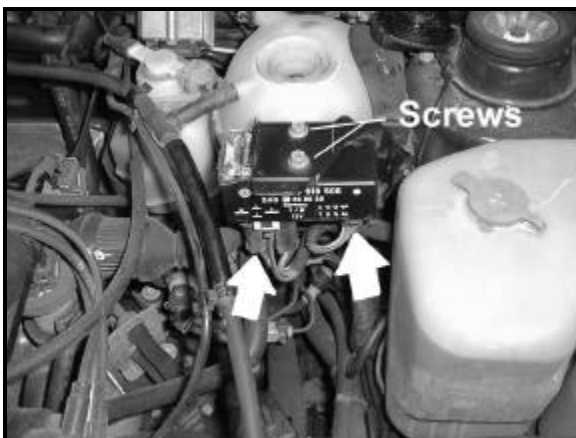
- ⇐ Remove (2) screws to remove coolant fan control module
- ⇐ Disconnect both electrical connectors (arrows) from control module
- Discard control module

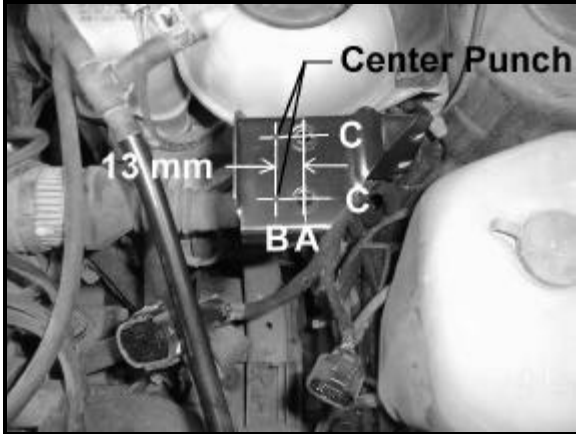
- ⇐ Using a pencil, draw a line (A) through the center of both holes on the control module mounting bracket
- ⇐ Draw another line (B) parallel and 13 mm (0.5 in) inward from hole center line (A)
- ⇐ Draw center line (C) of each hole across new parallel line
- ⇐ Center punch where both lines cross

- Drill (2) new 7 mm (9/32 in) holes

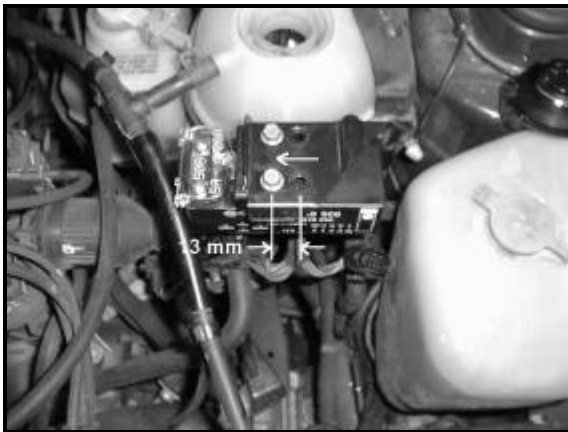
- ⇐ Install new cooling control module (3A0 919 506) from kit onto bracket at new hole location and secure with (2) screws

Note: Check for adequate clearance for opening fuse cover

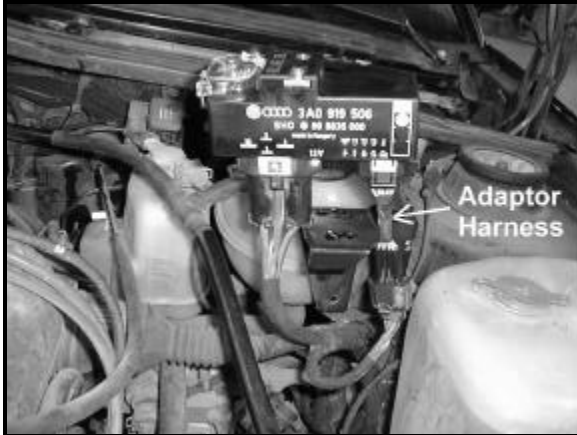
← If small connector is an 8 pin connector use adapter harness 535 971 566 from kit to connect to the 10 pin connector on the control module

- If small connector is a 10 pin connector, reconnect harness to control module; return the adapter 535 971 566 from kit to parts for inventory – no value

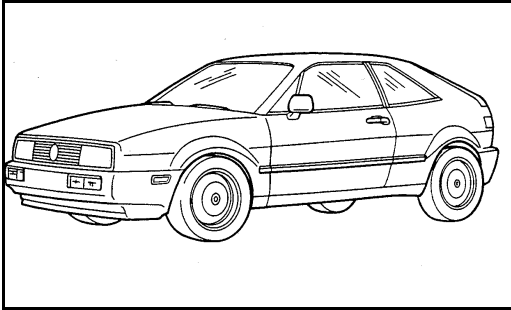
- Open hood and both front doors
- Record radio code and preset radio stations
- Disconnect the battery ground (GND) cable

- Loosen expansion tank cap
- Raise vehicle on hoist
- At left front of the vehicle, loosen clamp (Arrow) on lower radiator hose to radiator using special VW clamp removal tool
- Cautiously disconnect hose from the radiator to drain coolant

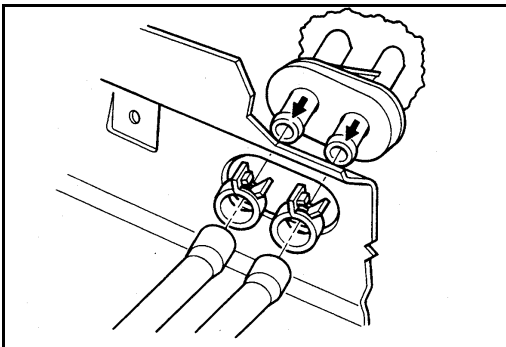
- Disconnect both heat exchanger hoses using special VW pliers, KL3385 or VAG 194 or similar and remove hoses
- Plug heat exchanger inlet and outlet pipes (use CO tap tube plugs or similar) to avoid spilling coolant (see Arrows)

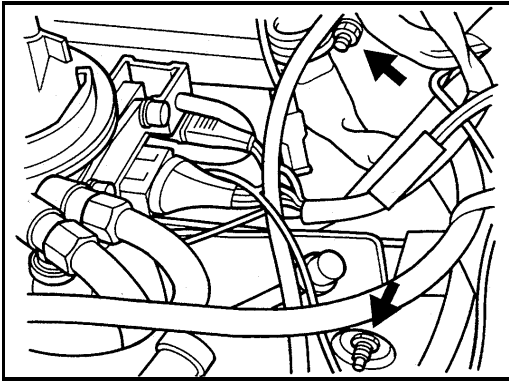
- Remove two 6mm heater-box-retaining nuts near ignition coil (Arrows)
- Remove left and right dashboard-securing nuts, located in water tray area

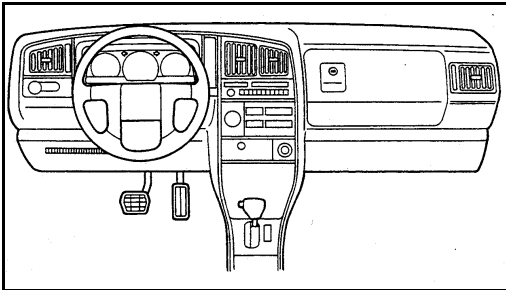
- Remove steering wheel
- Remove steering column trim
- Remove turn signal and wiper switches
- Remove left- and right-side lower dash panels
- Remove both kneebar panels
- Remove both upper vents
- Remove center vents
- Remove radio
- Remove temperature control unit; disconnect only control cable
- Remove ashtray and cigarette lighter

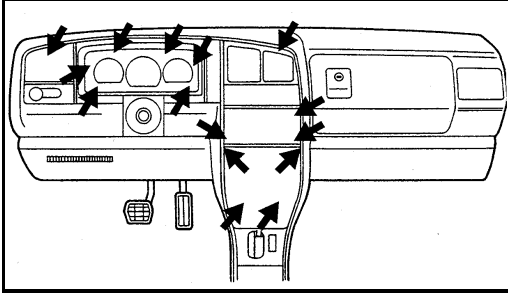
- Use special supplied tool-angle converter and remove **all** dashboard-fastening screws (Arrows) and:
 - Instrument cluster face plate
 - Instrument cluster

- Dashboard-fastening screw behind instrument cluster
- Remove all dashboard switches and disconnect speakers
- Remove dashboard screws on each end of dashboard

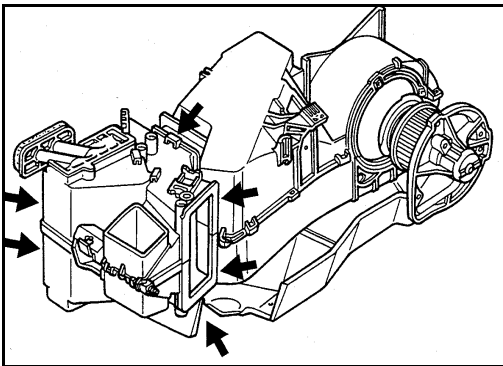
- Carefully remove all six securing clips
 - Arrows– holding heater box to evaporator/blower housing
- To remove the two clips on the firewall side, use a thin screwdriver

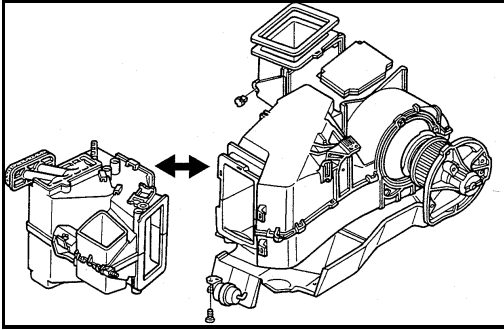
- Separate heater box from evaporator/blower housing

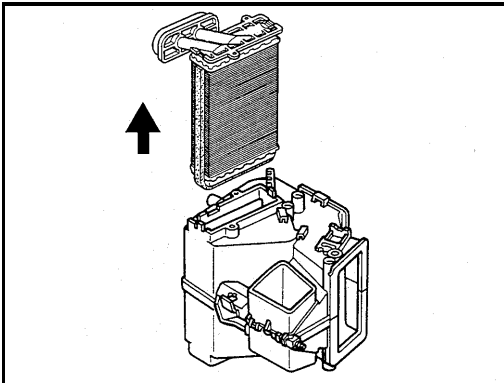
- Remove heat exchanger from heater housing – drain cooling fluid

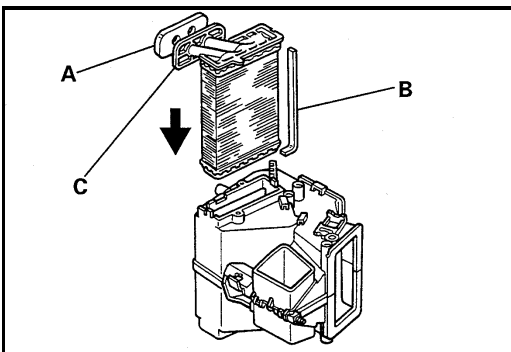
- Install new heat exchanger, part number 191 819 031F, into heater housing; seat properly
- Transfer vacuum hose connector pipe “C” from old to new unit
- Ensure that you affix new seal “A,” part number IHO 819 019, and foam strip “B,” part number 701 819 069, before installing heat exchanger

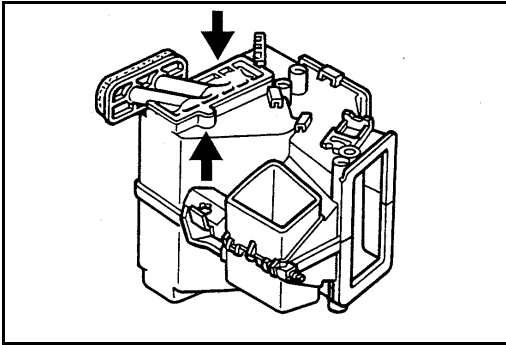
- If retaining clips holding the heat exchanger in place are broken, secure with two metal screws, part number N 01396612 (Arrows)

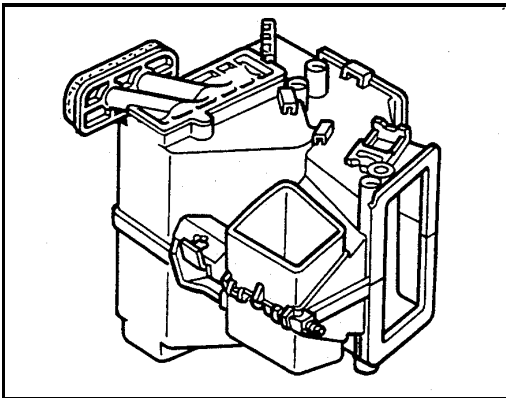
- Place heater box back inside vehicle; properly reconnect vacuum lines

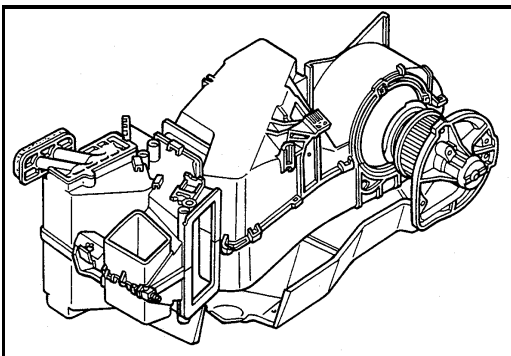
- Align heater box to evaporator/blower housing and slide together

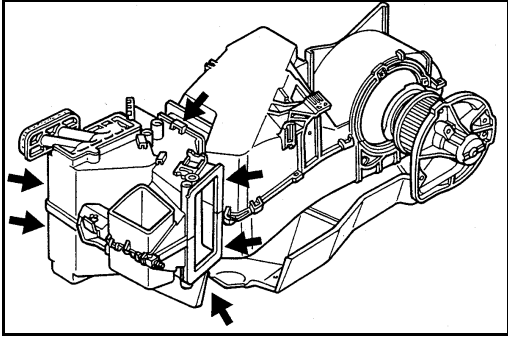
- Secure heater box with all six retaining clips, starting with front, top and bottom
- Between firewall and heater box, carefully push up the two clips from lower corner of edge ~ use caulking strip 10 hold clip to a screwdriver, or finger.
- Guide clip into position and secure clip

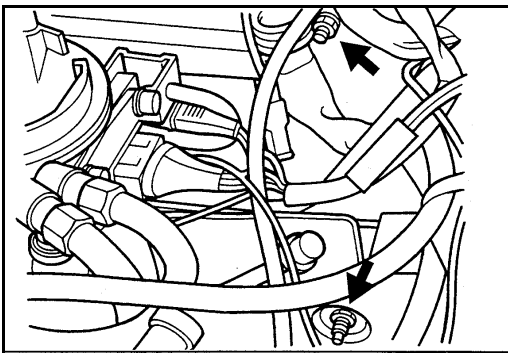
- Reinstall and tighten two 6mm nuts holding heater box to firewall (see Arrows)
- Reinstall and tighten two dashboard nuts in left and right water tray area

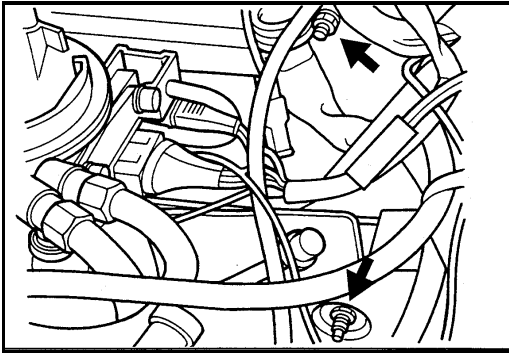
- Reconnect both heater hoses and secure with clamp, using special VW pliers, part number KL3385, VAG 1921 or similar
- Reconnect lower radiator hose to radiator and secure with clamp using new gasket, part number 059 121 119

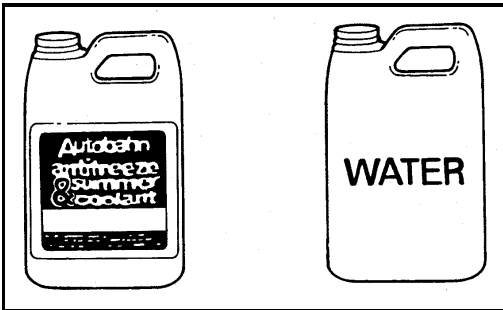
- Refill cooling system with new coolant mixture; use antifreeze, part number ZVW 237105, and mix 50/50 with water prior to filling
