1993 Volkswagen Corrado

1990-94 MAINTENANCE

Volkswagen Maintenance Information

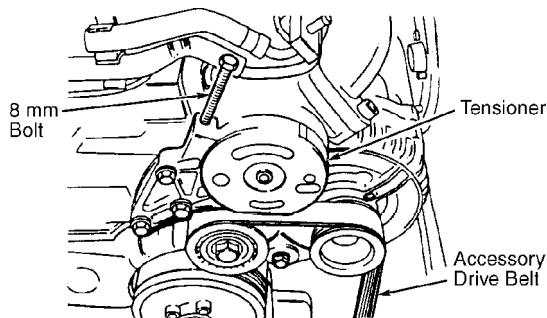
Fig. 1: Drive Belt Tensioner Adjustment (VR6)

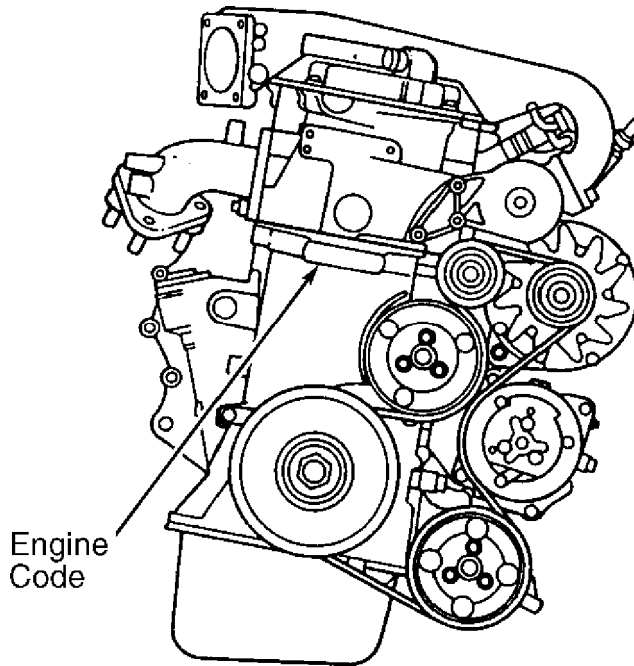
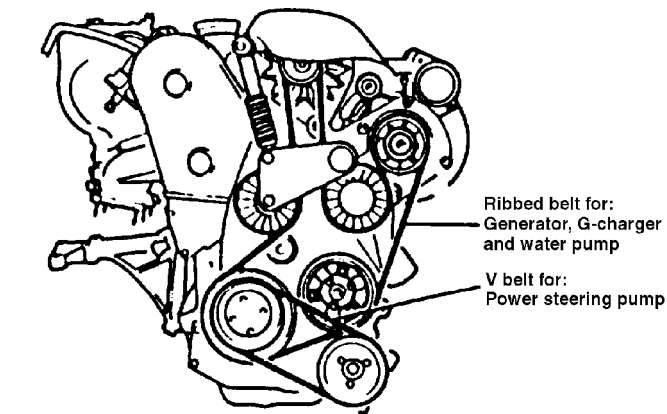
Fig. 2: Drive Belt Routing (VR6)

* Arrow = Tensioning point

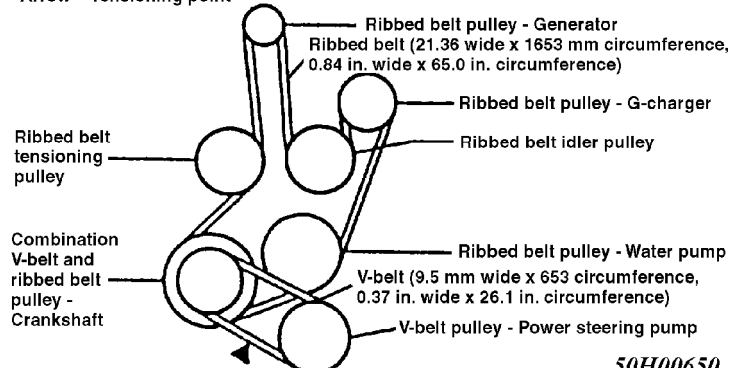
Fig. 3: Drive Belt Routing (Four Cylinder Without A/C)

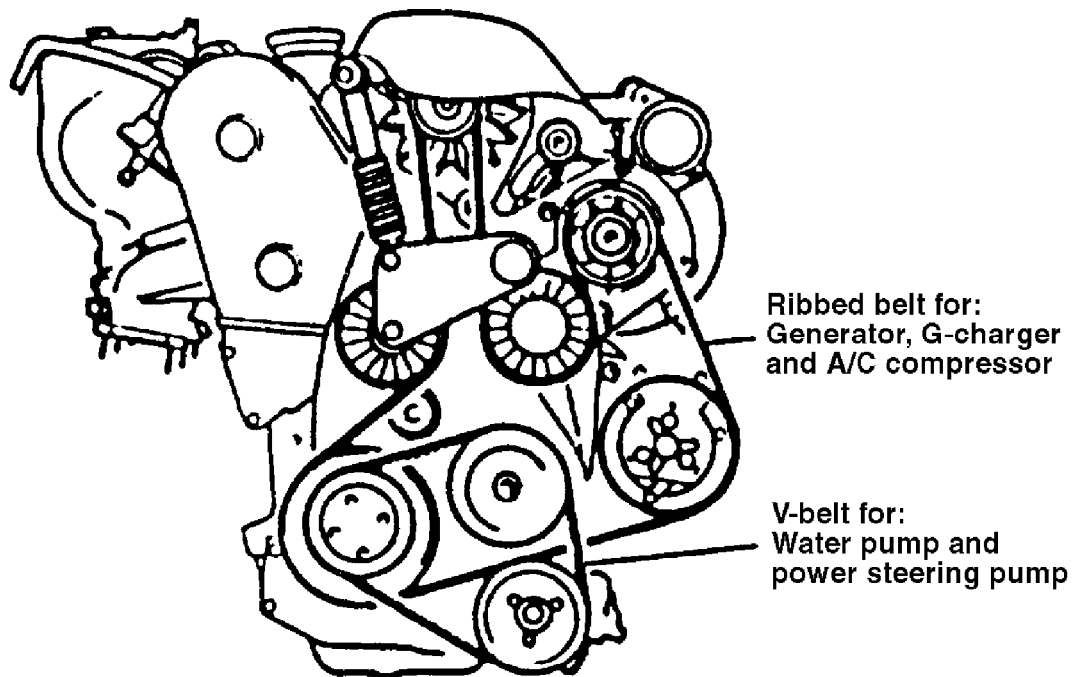
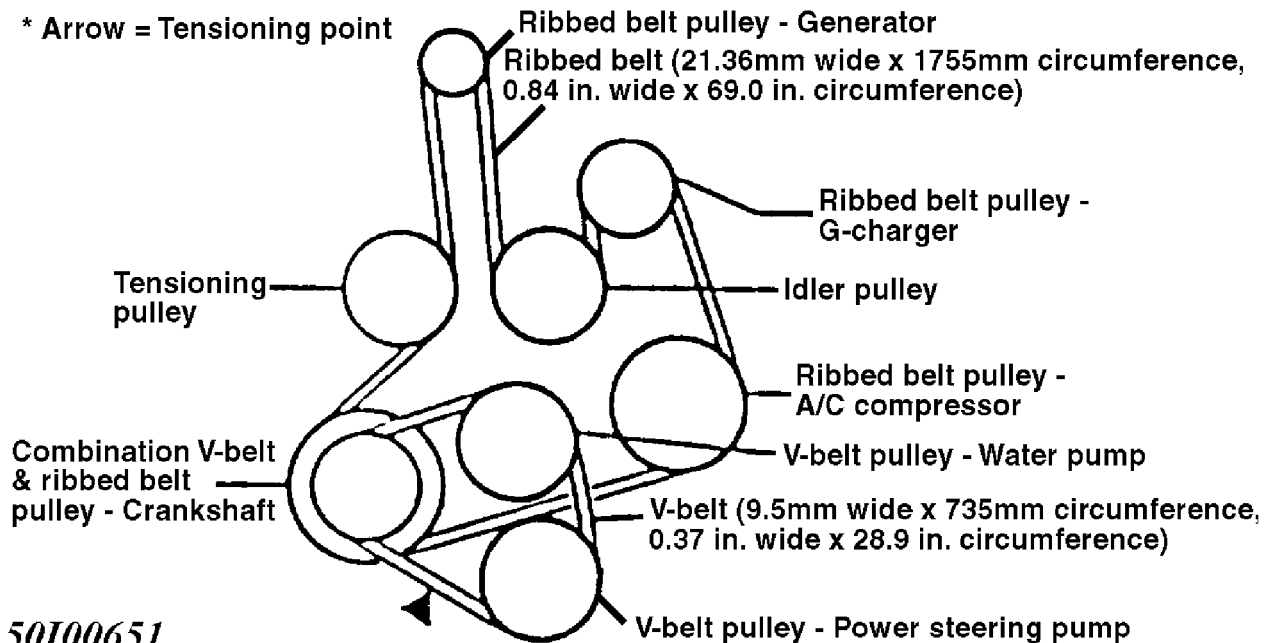
* Arrow = Tensioning point

Fig. 4: Drive Belt Routing (Four Cylinder With A/C)

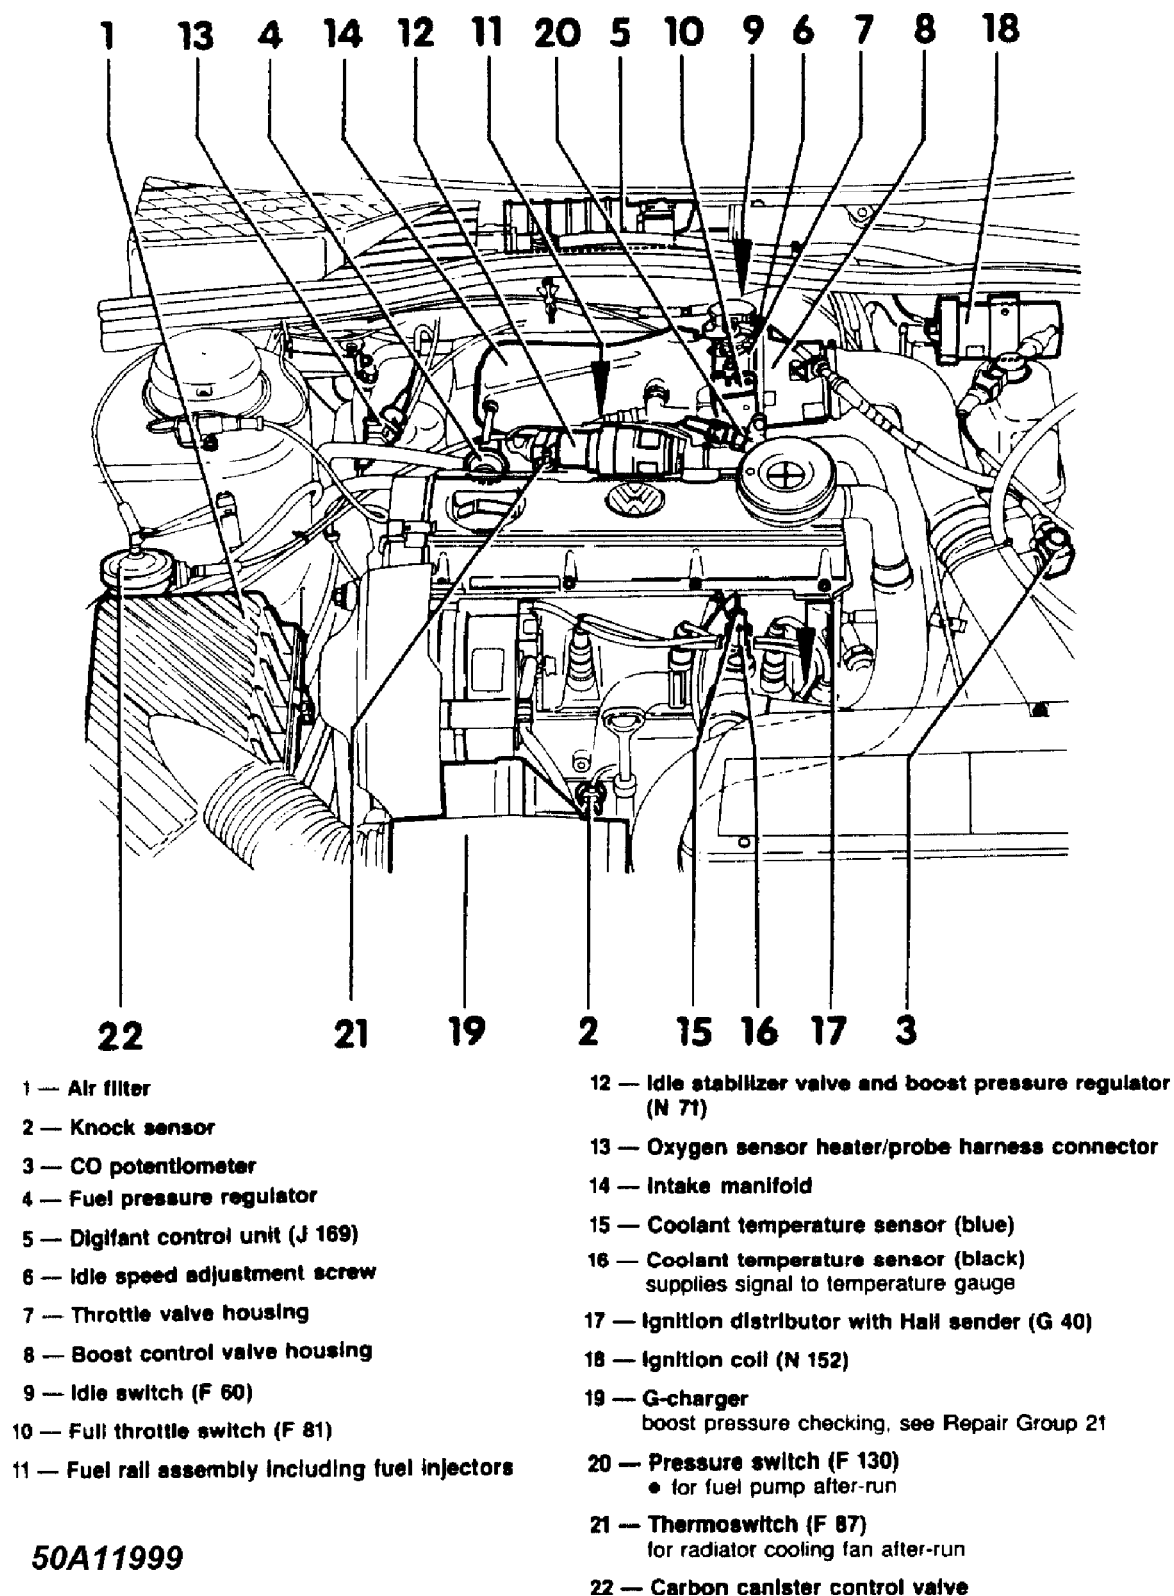
Fig. 5: Service Point Locations (1.8L 4-Cylinder)

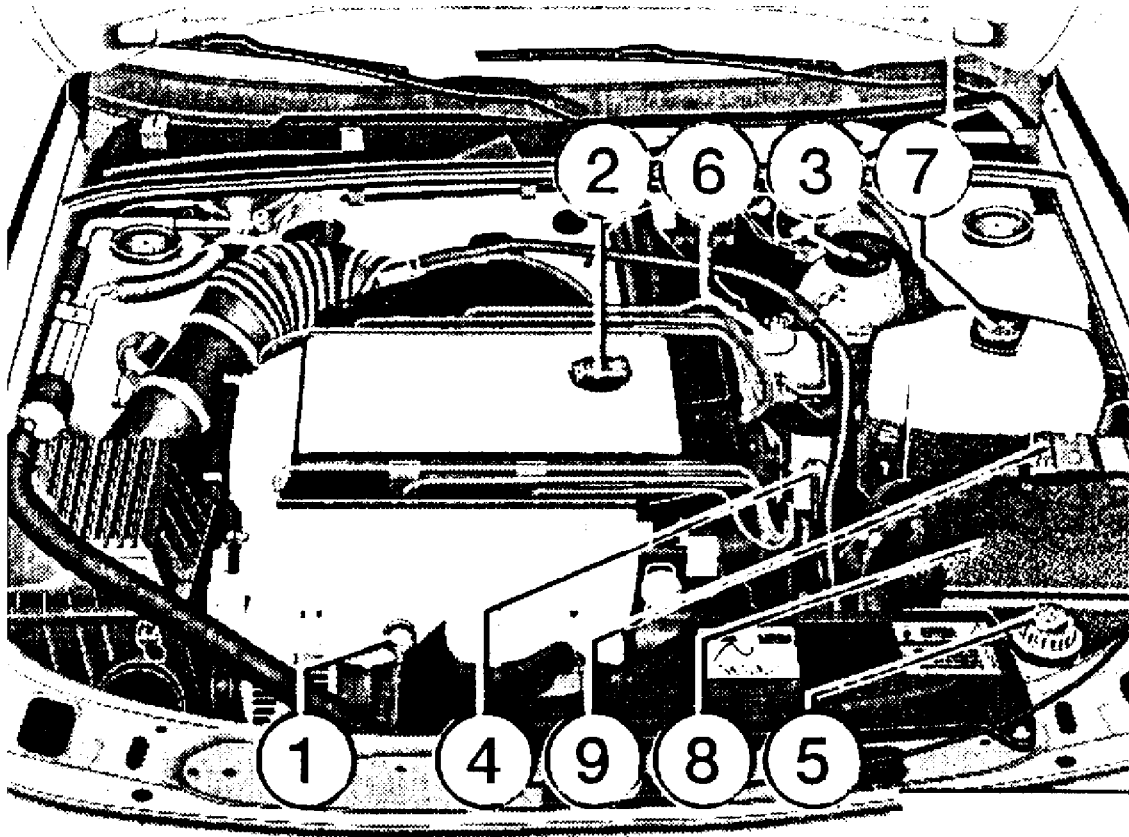
- 1 - Engine oil dipstick
- 2 - Engine oil filler cap
- 3 - Coolant expansion tank
- 4 - ATF-dipstick*
- 5 - Power steering reservoir
- 6 - Brake fluid reservoir
- 7 - Windshield washer container
- 8 - Battery (protected by a cover)
- 9 - Fuse for coolant-fan after run
(For service use only) **50B11966**

Fig. 6: Service Point Locations (2.8L V6)
Courtesy of Volkswagen United States, Inc.

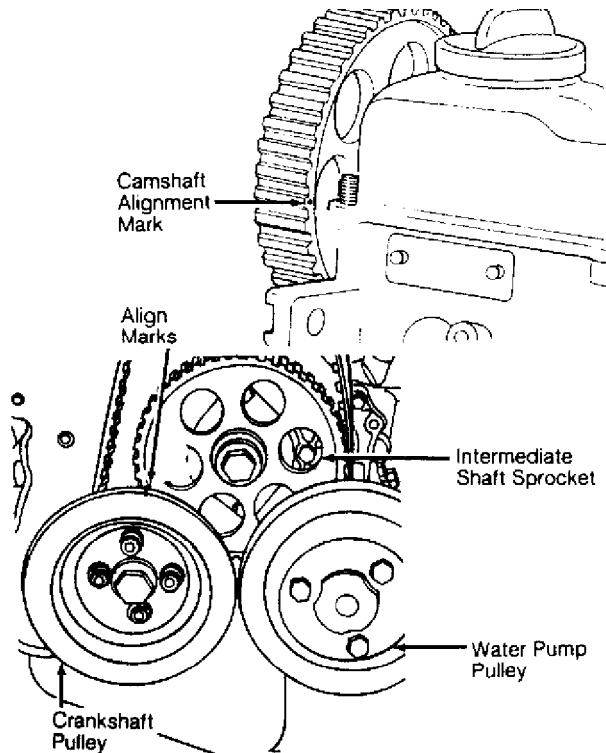
Fig. 7: Aligning 1.8L Timing Marks (8-Valve)
Courtesy of Volkswagen United States, Inc.

NOTE: For more information on camshaft timing belt service refer to the 1.8L 4-CYL 8-VALVE & 2.0L 4-CYL 16-VALVE article in the ENGINE MECHANICAL section.

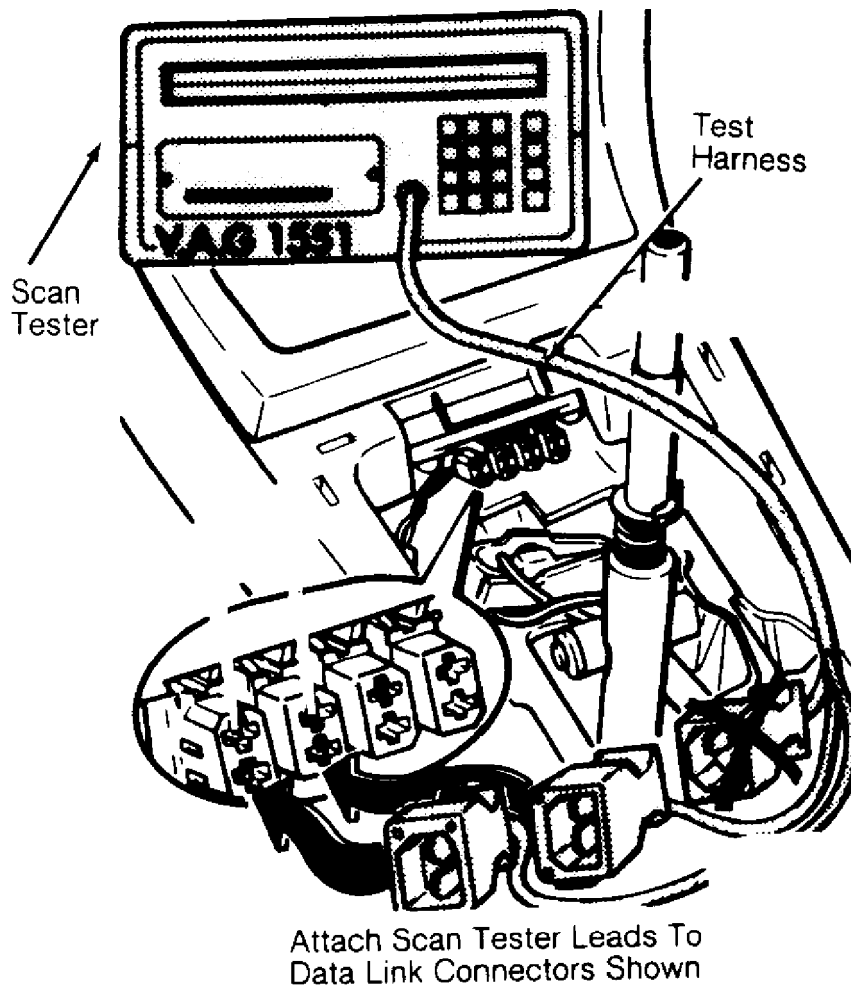
Fig. 8: Connecting Scan Tester to Data Link Connector (Corrado)
Courtesy of Volkswagen United States, Inc.

NOTE: For more information on scan tester connections refer to the G - TESTS W/CODES article in the ENGINE PERFORMANCE section.

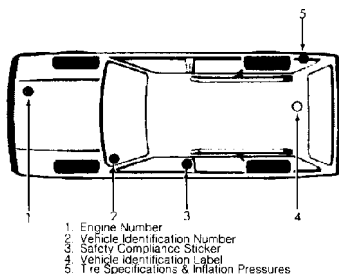
Fig. 9: Information Label Locations
Courtesy of Volkswagen United States, Inc.

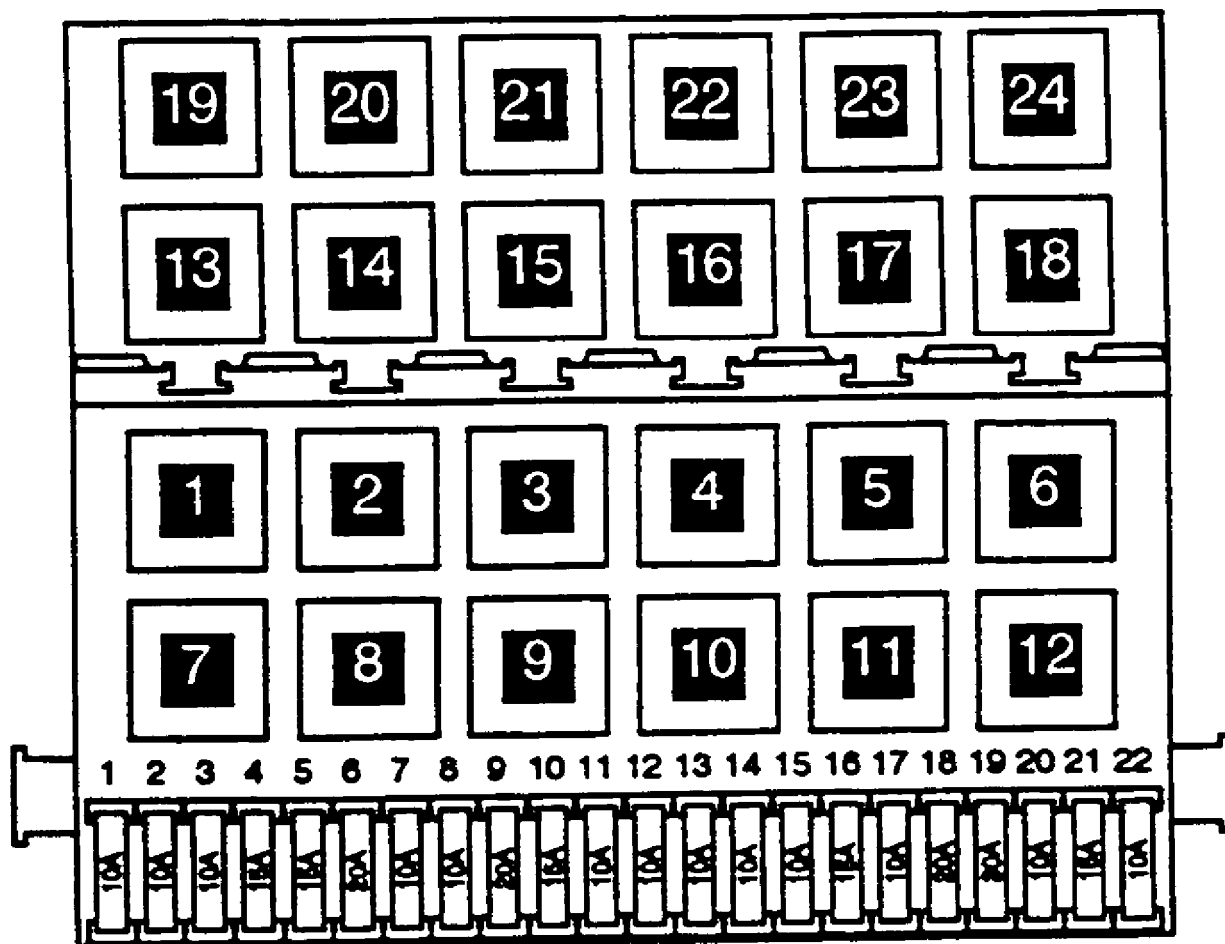
Fuse panel is located under left side of dash board by driver's knee. Fuses are numbered from left to right.

Fig. 10: Fuse & Relay Panel Identification (1990)

- 1 - 10 Amp (Red)
Left Low Beam
- 2 - 10 Amp (Red)

- Right Low Beam
- 3 - 10 Amp (Red)
Instrument Lights, License Plate Lights
- 4 - 15 Amp (Blue)
Rear Window Wiper, Sliding Roof
- 5 - 15 Amp (Blue)
Windshield & Rear Window Washer, Windshield Wiper

- 6 - 20 Amp (Yellow)
Air Conditioner, Fresh Air Fan
- 7 - 10 Amp (Red)
Right Tail & Side Lights
- 8 - 10 Amp (Red)
Left Tail & Side Lights
- 9 - 20 Amp (Yellow)
Rear Window Defroster, Mirror Heating

- 10 - 15 Amp (Blue)
Foglights
- 11 - 10 Amp (Red)
Left High Beam, High Beam Indicator
- 12 - 10 Amp (Red)
Right High Beam
- 13 - 10 Amp (Red)
Horn, Radiator Fan

- 14 - 15 Amp (Blue)
Back-Up Lights, Electric Mirrors, Heated Washer Jets
- 15 - 10 Amp (Red)
Electronic Ignition, Idle Stabilizer,
Deceleration Fuel Shut Off

- 16 - 15 Amp (Blue)
Warning/Indicator Lights, Multi-Function Indicator, Glove Box
Light, Cassette Storage Light, Rear Spoiler Control Unit
- 17 - 10 Amp (Red)
Emergency Flashers, Turn Signals

- 18 - 20 Amp (Yellow)
Fuel Pump, Heated Oxygen Sensor
- 19 - 30 Amp (Green)
Radiator Fan, Air Conditioner
- 20 - 10 Amp (Red)
Brake Lights, Cruise Control
- 21 - 15 Amp (Blue)
Interior Compartment Lights, Cigarette Lighter, Digital Clock
Central Locking System, Rear Spoiler Adjustment

- 1 - A/C Control Module Relay
- 2 - Rear Window Wiper/Washer Relay
- 3 - ECM Power Supply Relay
- 4 - Load Reduction Relay
- 5 - Low Coolant Level

- 6 - Emergency Flasher Relay
- 7 - Not Used
- 8 - Washer/Wiper Intermittent Relay
- 9 - Seat Belt Warning Control Module
- 10 - Fog Lamp/Parking Lamp Relay
- 11 - Dual Horn Relay
- 12 - Fuel Pump Relay
- 13 - ABS Hydraulic Pump Relay
- 14 - ABS Relay
- 15 - Radiator After Run Relay
- 16 - Fuel Pump After Run Control Unit
- 17 - Heated Driver Seat Relay
- 18 - Heated Passenger Seat Relay
- 19 - ABS Hydraulic Pump Fuse (30 Amp)
- 20 - ABS Hydraulic Valve Fuse (30 Amp)
- 21 - Power Window Fuse (20 Amp)
- 22 - ABS Valves Fuse (30 Amp)
- 23 - Not Used
- 24 - Not Used

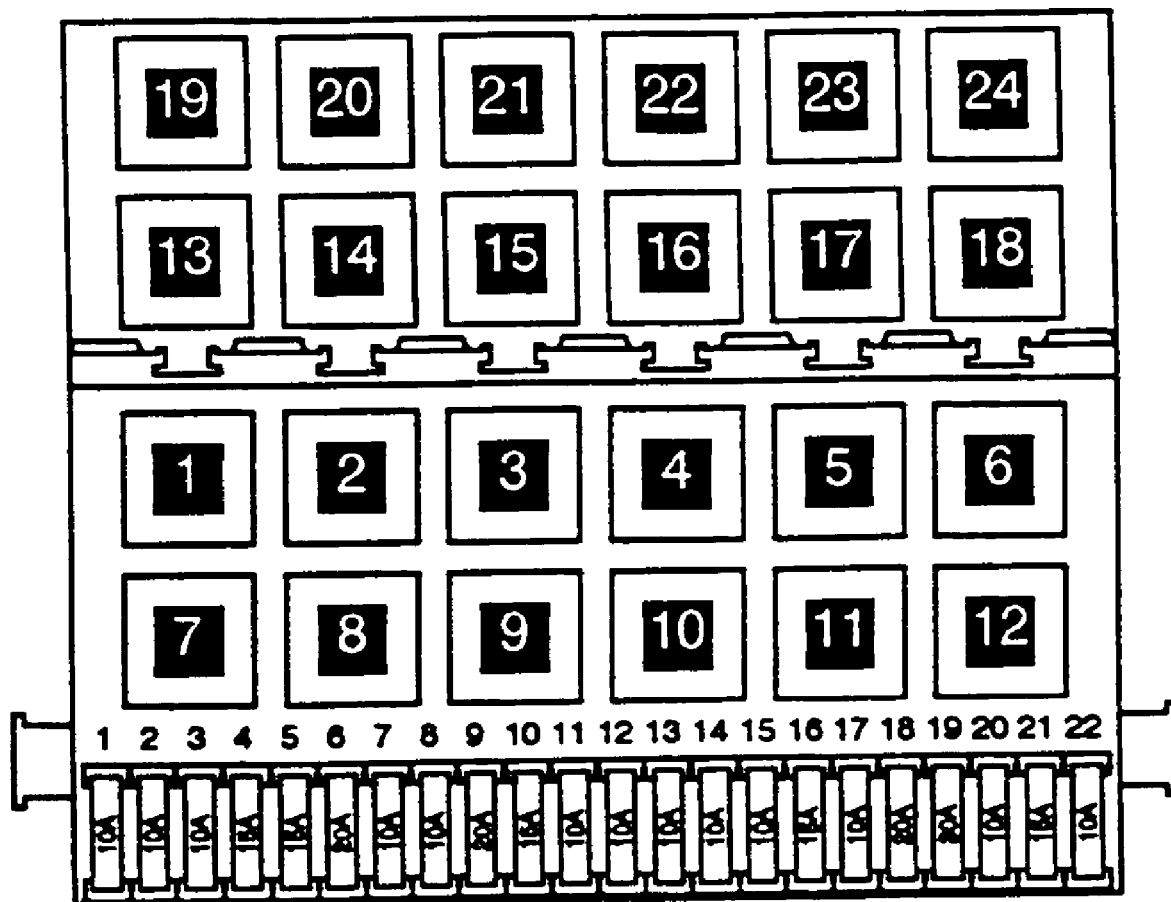
Fig. 11: Fuse & Relay Panel ID (1991-92)
Courtesy of Volkswagen United States, Inc.

- 1 - 10 Amp (Red)
Left Low Beam
- 2 - 10 Amp (Red)
Right Low Beam
- 3 - 10 Amp (Red)
Instrument Lights, License Plate Lights
- 4 - 15 Amp (Blue)
Rear Window Wiper, Sliding Roof

- 5 - 15 Amp (Blue)
Windshield & Rear Window Washer, Windshield Wiper
- 6 - 20 Amp (Yellow)
Air Conditioner, Fresh Air Fan
- 7 - 10 Amp (Red)
Right Tail & Side Lights

- 8 - 10 Amp (Red)
Left Tail & Side Lights
- 9 - 20 Amp (Yellow)
Rear Window Defroster, Mirror Heating
- 10 - 15 Amp (Blue)
Foglights
- 11 - 10 Amp (Red)
Left High Beam, High Beam Indicator

- 12 - 10 Amp (Red)
Right High Beam
- 13 - 10 Amp (Red)
Horn, Radiator Fan
- 14 - 15 Amp (Blue)
Back-Up Lights, Electric Mirrors, Heated Washer Jets
- 15 - 10 Amp (Red)
Electronic Ignition, Idle Stabilizer,
Deceleration Fuel Shut Off

- 16 - 15 Amp (Blue)
Warning/Indicator Lights, Multi-Function Indicator, Glove Box
Light, Cassette Storage Light, Rear Spoiler Control Unit
- 17 - 10 Amp (Red)
Emergency Flashers, Turn Signals

- 18 - 20 Amp (Yellow)
Fuel Pump, Heated Oxygen Sensor
- 19 - 30 Amp (Green)
Radiator Fan, Air Conditioner
- 20 - 10 Amp (Red)
Brake Lights, Cruise Control
- 21 - 15 Amp (Blue)
Dome & Luggage Compartment Lights, Cigarette Lighter, Clock
Central Locking System, Multi-Function Indicator,
Rear Spoiler Adjustment, Engine Diagnostic

- 1 - A/C Control Module Relay
- 2 - Rear Window Wiper/Washer Relay
- 3 - ECM Power Supply Relay
- 4 - Load Reduction Relay
- 5 - Not Used
- 6 - Emergency Flasher Relay
- 7 - Not Used
- 8 - Washer/Wiper Intermittent Relay
- 9 - Seat Belt Warning Control Module
- 10 - Fog Lamp/Parking Lamp Relay
- 11 - Dual Horn Relay
- 12 - Fuel Pump Relay
- 13 - ABS Hydraulic Pump Relay
- 14 - ABS Relay
- 15 - Radiator After Run Relay
- 16 - Fuel Pump After Run Control Unit
- 17 - Heated Driver Seat Relay
- 18 - Heated Passenger Seat Relay
- 19 - ABS Hydraulic Pump Fuse (30 Amp)
- 20 - ABS Hydraulic Valve Fuse (30 Amp)
- 21 - Power Window Fuse (20 Amp)
- 22 - ABS Valves Fuse (30 Amp)
- 23 - Automatic Seat Belt System Fuse, S51
- 24 - Not Used

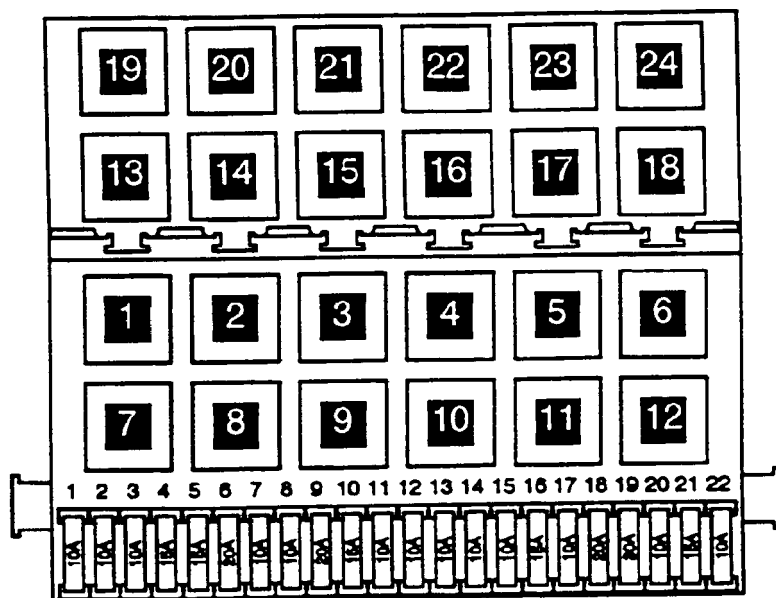
Fig. 12: Fuse & Relay Panel ID (1993 - up to January 1993)
Courtesy of Volkswagen United States, Inc.

- 1 - 10 Amp (Red)
Left Low Beam
- 2 - 10 Amp (Red)
Right Low Beam
- 3 - 10 Amp (Red)
Instrument Lights, License Plate Lights
- 4 - 15 Amp (Blue)
Rear Window Wiper, Sliding Roof

- 5 - 15 Amp (Blue)
Windshield & Rear Window Washer, Windshield Wiper
- 6 - 20 Amp (Yellow)
Air Conditioner, Fresh Air Fan
- 7 - 10 Amp (Red)
Right Tail & Side Lights

- 8 - 10 Amp (Red)
Left Tail & Side Lights
- 9 - 20 Amp (Yellow)
Rear Window Defroster, Mirror Heating
- 10 - 15 Amp (Blue)
Foglights
- 11 - 10 Amp (Red)
Left High Beam, High Beam Indicator

- 12 - 10 Amp (Red)
Right High Beam
- 13 - 10 Amp (Red)
Horn, Radiator Fan
- 14 - 15 Amp (Blue)
Back-Up Lights, Electric Mirrors, Heated Washer Jets
- 15 - 10 Amp (Red)
Crankcase Ventilation Heating Element

- 16 - 15 Amp (Blue)
Warning/Indicator Lights, Multi-Function Indicator, Glove Box Light, Cassette Storage Light, Rear Spoiler Control Unit
- 17 - 10 Amp (Red)
Emergency Flashers, Turn Signals

- 18 - 20 Amp (Yellow)
Fuel Pump, Heated Oxygen Sensor Control
- 19 - 30 Amp (Green)
Radiator Fan, Air Conditioner
- 20 - 10 Amp (Red)
Brake Lights, Cruise Control

- 21 - 15 Amp (Blue)
Dome & Luggage Compartment Lights, Cigarette Lighter, Clock Central Locking System, Multi-Function Indicator, Rear Spoiler Adjustment

- 1 - A/C Control Module Relay
- 2 - Rear Window Wiper/Washer Relay
- 3 - ECM Power Supply Relay
- 4 - Load Reduction Relay
- 5 - Not Used
- 6 - Emergency Flasher Relay
- 7 - Headlight Washer Relay
- 8 - Washer/Wiper Intermittent Relay
- 9 - Seat Belt Warning Control Module
- 10 - Fog Lamp/Parking Lamp Relay
- 11 - Dual Horn Relay
- 12 - Fuel Pump Relay
- 13 - ABS Hydraulic Pump Relay
- 14 - ABS Relay
- 15 - Not Used
- 16 - Not Used
- 17 - Not Used
- 18 - Power Seat Fuse
- 19 - ABS Hydraulic Pump Fuse
- 20 - ABS Hydraulic Valve Fuse
- 21 - Not Used
- 22 - Power Window Circuit Breaker
- 23 - Fuse, S51
- 24 - Not Used

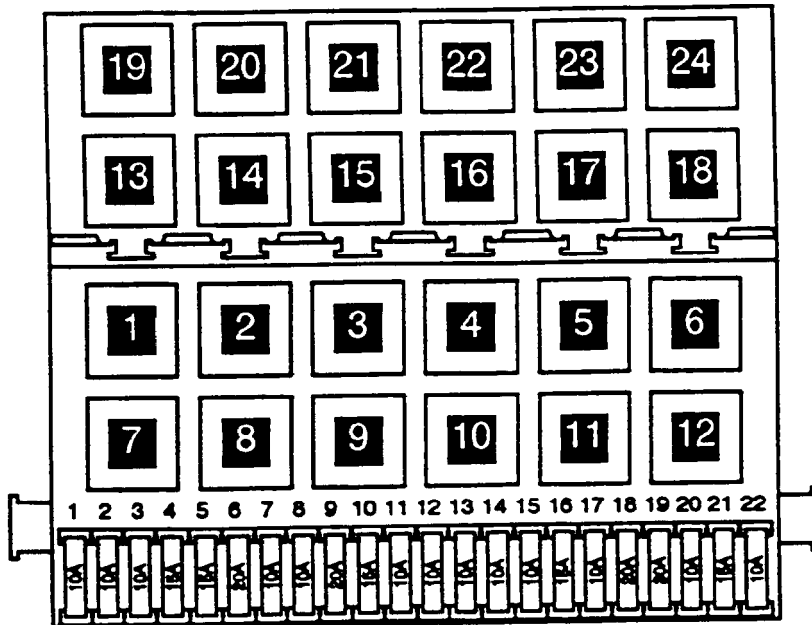
Fig. 13: Fuse & Relay Panel ID (1993 - from January 1993-94)
Courtesy of Volkswagen United States, Inc.

- 1 - 10 Amp (Red)
Left Low Beam
- 2 - 10 Amp (Red)
Right Low Beam
- 3 - 10 Amp (Red)
Instrument Lights, License Plate Lights
- 4 - 15 Amp (Blue)
Rear Window Wiper, Sliding Roof

- 5 - 15 Amp (Blue)
Windshield & Rear Window Washer, Windshield Wiper
- 6 - 20 Amp (Yellow)
Air Conditioner, Fresh Air Fan
- 7 - 10 Amp (Red)
Right Tail & Side Lights

- 8 - 10 Amp (Red)
Left Tail & Side Lights
- 9 - 20 Amp (Yellow)
Rear Window Defroster, Mirror Heating
- 10 - 15 Amp (Blue)
Foglights
- 11 - 10 Amp (Red)
Left High Beam, High Beam Indicator

- 12 - 10 Amp (Red)
Right High Beam
- 13 - 10 Amp (Red)
Horn, Radiator Fan
- 14 - 15 Amp (Blue)
Back-Up Lights, Electric Mirrors, Heated Washer Jets
- 15 - 10 Amp (Red)
Crankcase Ventilation Heating Element

- 16 - 15 Amp (Blue)
Warning/Indicator Lights, Multi-Function Indicator, Glove Box Light, Cassette Storage Light, Rear Spoiler Control Unit
- 17 - 10 Amp (Red)
Emergency Flashers, Turn Signals

- 18 - 20 Amp (Yellow)
Fuel Pump, Heated Oxygen Sensor
- 19 - 30 Amp (Green)
Radiator Fan, Air Conditioner
- 20 - 10 Amp (Red)
Brake Lights, Cruise Control
- 21 - 15 Amp (Blue)
Dome & Luggage Compartment Lights, Cigarette Lighter, Clock Central Locking System, Multi-Function Indicator, Rear Spoiler Adjustment

- 1 - A/C Control Module Relay
- 2 - Rear Window Wiper/Washer Relay
- 3 - ECM Power Supply Relay
- 4 - Load Reduction Relay
- 5 - Engine Coolant Level (ECL) Control Module
- 6 - Emergency Flasher Relay
- 7 - Headlight Washer Relay
- 8 - Washer/Wiper Intermittent Relay
- 9 - Seat Belt Warning Control Module
- 10 - Fog Lamp/Parking Lamp Relay
- 11 - Dual Horn Relay
- 12 - Fuel Pump Relay
- 13 - Back-Up Light Fuse (A/T)
- 14 - Coolant After-Run Control Module
- 15 - ABS Hydraulic Pump Relay
- 16 - ABS Relay
- 17 - Not Used
- 18 - Power Seat Fuse
- 19 - A/C Relay
- 20 - Park/Neutral Position (PNP) Relay
- 21 - ABS Hydraulic Pump Fuse/Power Window Circuit Breaker
- 22 - ABS Hydraulic Valve Fuse
- 23 - Cruise Control Fuse/Automatic Shoulder Belt System Fuse
- 24 - Not Used
