# TRANSMISSION SERVICING - M/T

1993 Volkswagen Passat

1993 TRANSMISSION SERVICING  
Volkswagen Manual Transmission

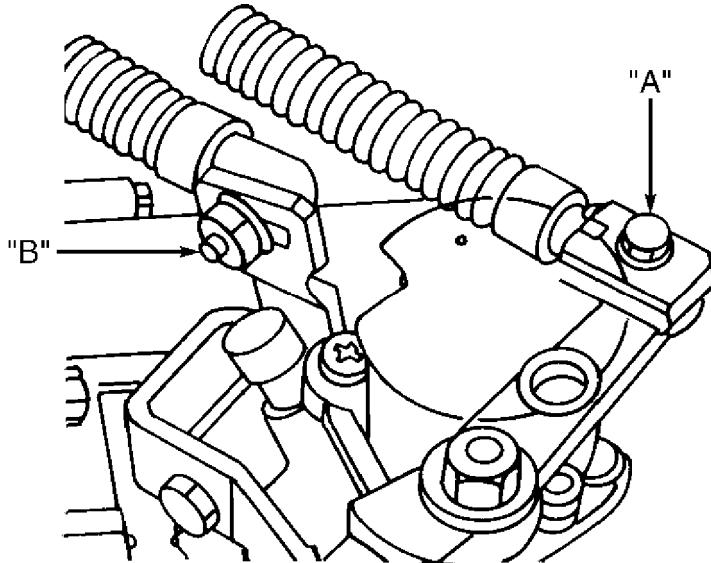
92G01413

Fig. 1: Identifying Centering Holes  
Courtesy of Volkswagen United States, Inc.

1) Place gearshift lever in Neutral position. Remove knob and boot. Loosen bolt "A" and nut "B" sufficiently so that operating cables move freely in centering holes. See Fig. 1. Install Shift

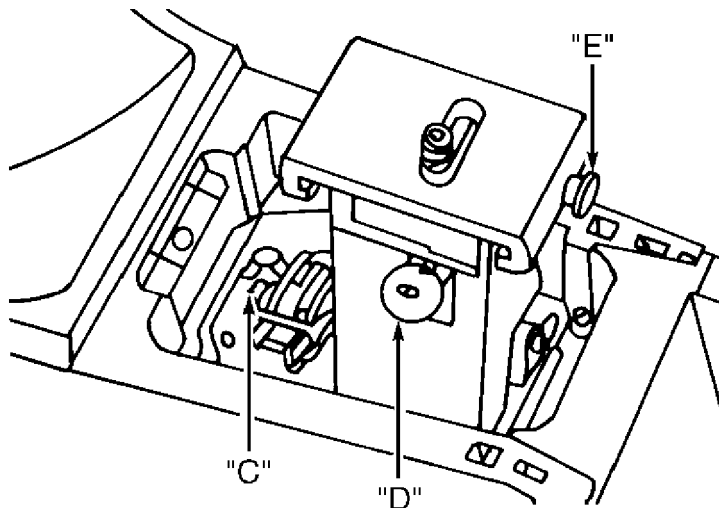
92I01414

Fig. 2: Installing Shift Linkage Gauge  
Courtesy of Volkswagen United States, Inc.

Linkage Gauge (3193). Loosen bolt "C". See Fig. 2.

2) Pivot locating pin under bearing plate. Tighten nut "D". Place gearshift lever into left detent of slide. Move gearshift lever and slide together to left stop. Tighten slide with bolt "D". Move gearshift lever to right detent. Tighten bolt "E". Move gearshift lever to right detent. Tighten bolt "C".
