DRIVE AXLE - GEAR TOOTH CONTACT PATTERNS

1991 Volkswagen Vanagon
For Volkswagen Technical Site
Copyright © 1998 Mitchell Repair Information Company, LLC
Saturday, March 18, 2000 09:03PM

1983-93 DRIVE AXLES
Gear Tooth Contact Patterns

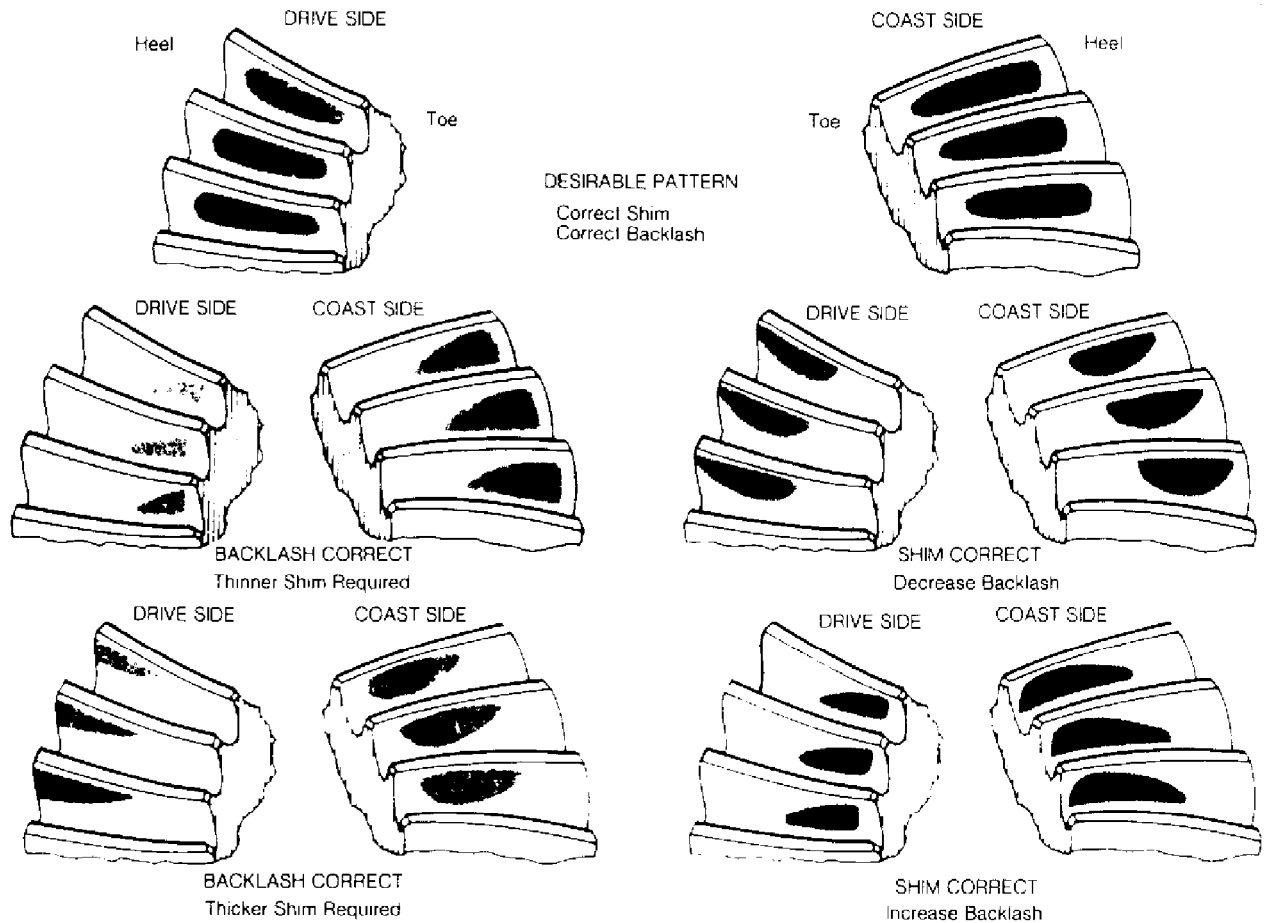
Fig. 1: Drive Axle Gear Tooth Patterns

NOTE: Drive pattern should be well centered on ring gear teeth. Coast pattern should be centered, but may be slightly toward toe of ring gear teeth.

1) With no change in backlash, moving pinion further from ring gear moves drive pattern toward heel and top of tooth, and moves coast pattern toward toe and top of tooth.

2) With no change in backlash, moving pinion closer to ring gear moves drive pattern toward toe and bottom of tooth, and moves coast pattern toward heel and bottom of tooth.

3) With no change in pinion shim thickness, an increase in backlash moves ring gear further from pinion. Drive pattern moves toward heel and top of tooth, and coast pattern moves toward heel and top of tooth.

4) With no change in pinion shim thickness, decrease in backlash moves ring gear closer to pinion gear. Drive pattern moves toward toe and bottom of tooth, and coast pattern moves toward toe and bottom of tooth.
